Monthly Oversight Report 21
ACS NPL Site
Griffith, Indiana
August 31, 2002 - September 27, 2002

Subject: Monthly Oversight Summary Report
No. 21 for September 2002

Monthly Oversight Summary Report No. 21
ACS Superfund Site WA57, 46526.238

Reporting Period: Month of September (August 31, 2002 - September 27, 2002)
BVSPC O/S Dates: September 4, 5, 10, 12, 17, 19, 24, and 26, 2002

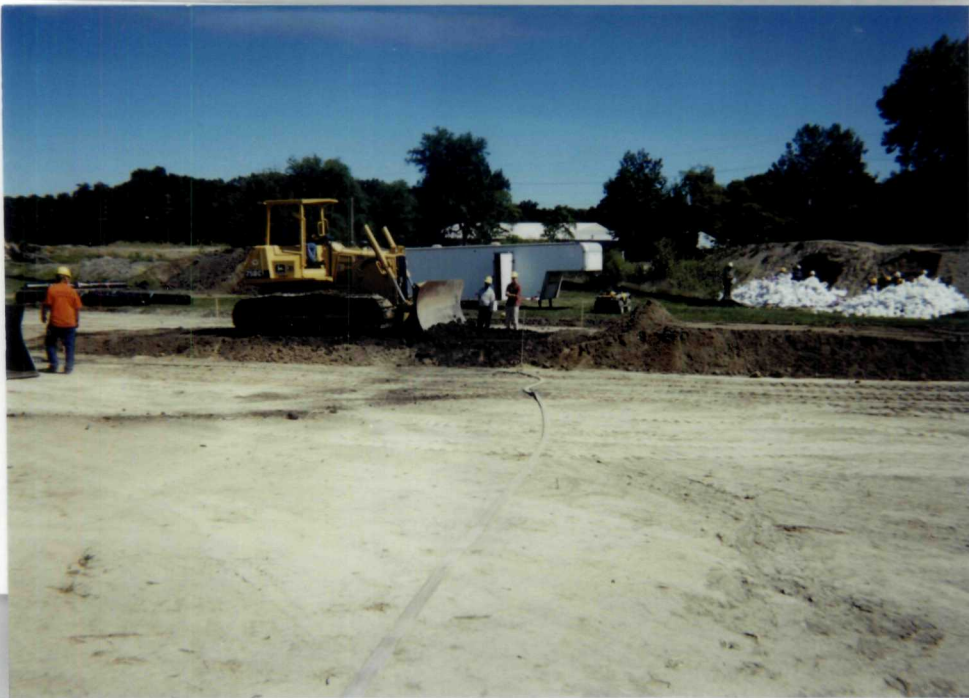
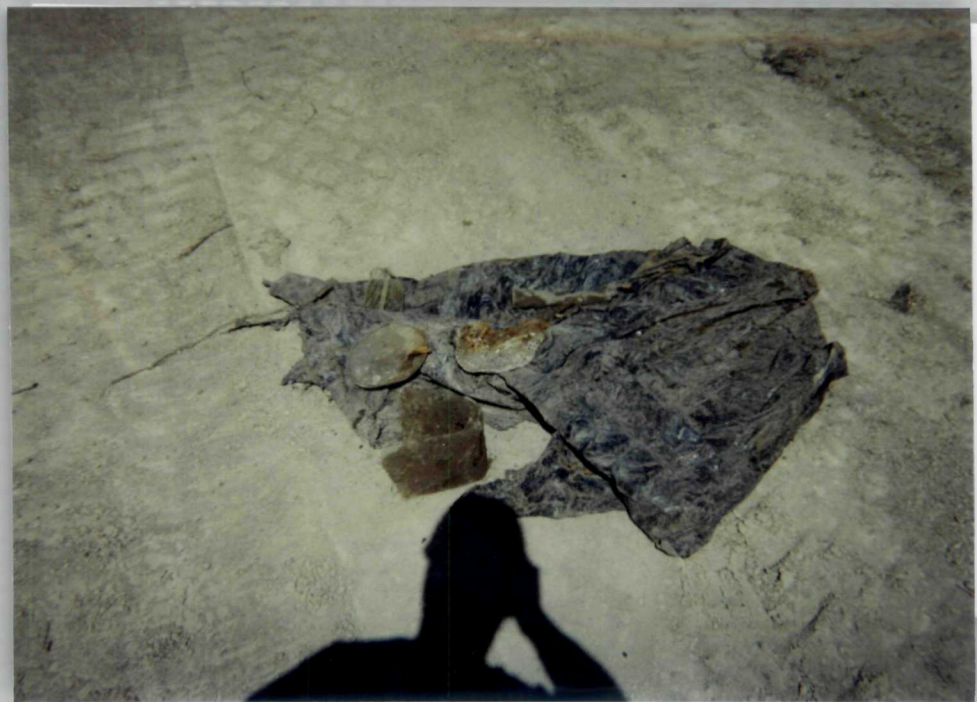
- The anchor trench for the OFCA FML appears to be crossing inside the barrier wall.
- BVSPC observed shallow debris buried along the west side of the OFCA, uncovered during anchor trench excavation activities.

- BVSPC expressed concern over the drainage of the anchor trench based on its current construction.
- BVSPC observed shallow buried debris along the west side of the OFCA, uncovered during anchor trench excavation activities.

Description: Photo facing northwest near the west side of the OFCA anchor trench looking at ground and debris that was encountered during trenching activities.

- MWH reported the anchor trench for the OFCA FML was installed outside of the barrier wall.
- MWH reported that the observed debris was from the Town of Griffith landfill and that the OFCA cover inside the barrier wall was constructed with a 12-inch-thick layer of clay.

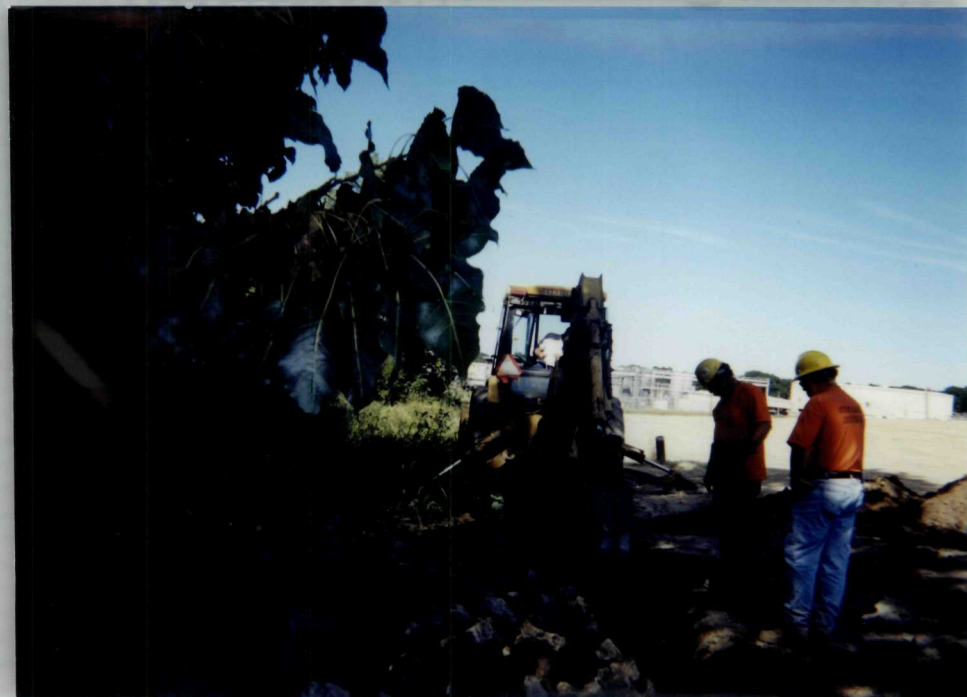
- The anchor trench for the OFCA FML appears to be crossing over the barrier wall liner in several locations.
- BVSPC observed that portions of the barrier wall HDPE may have been compromised during anchor trench excavation activities.

Site: American Chemical Services, Inc.
 Proj. #: 46526
 Roll: 26 Photo #10
 Date: 09-04-02 Time: 08:15
 Photographer: Chad Gailey
 Description: Photo facing north at the western anchor trench showing ECI excavating near the boundary of the barrier wall.

- MWH investigated the damage to the barrier wall HDPE and determined that the damage to the liner was limited to the areas observed and did not compromise the integrity of wall.

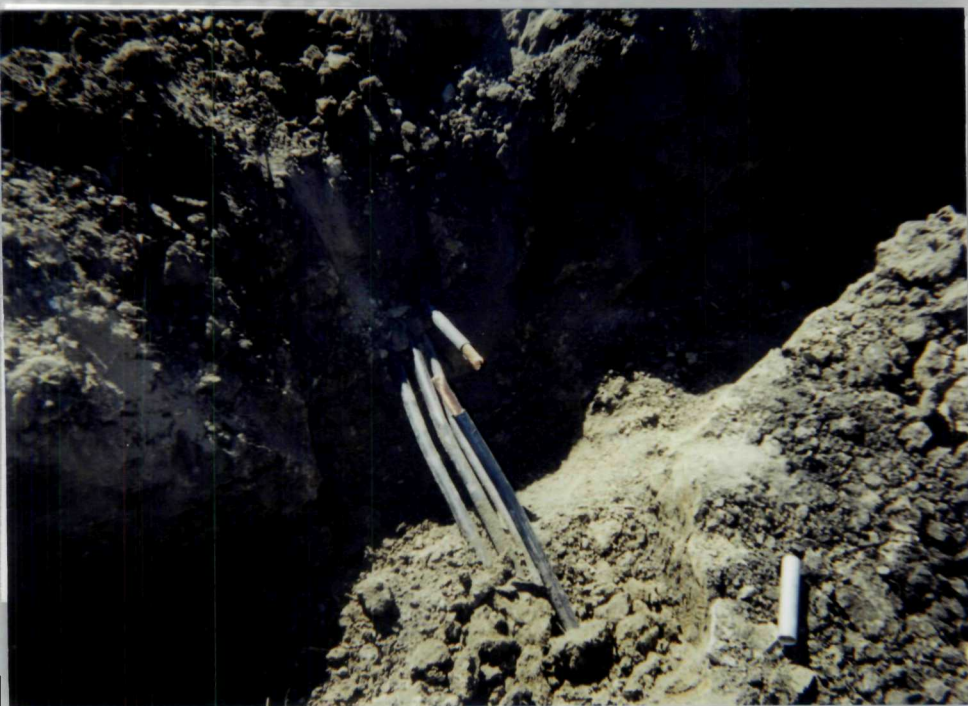
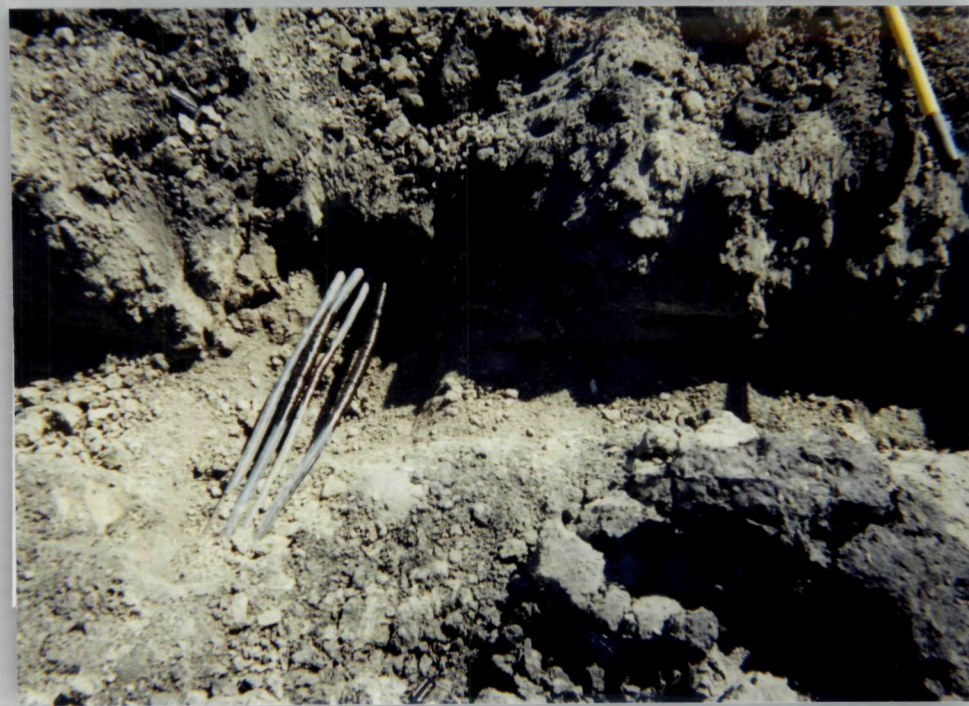
While excavating the anchor trench on the eastern portion of the OFCA on September 5, 2002, ECI damaged the buried electrical conduit that runs from Colfax Ave. to the blower shed. A spark was generated; however, no injuries occurred. Austgen was on-site later that morning and repaired the electrical line.

Description: Photo facing southeast at ground showing the repaired electrical lines in the eastern anchor trench.

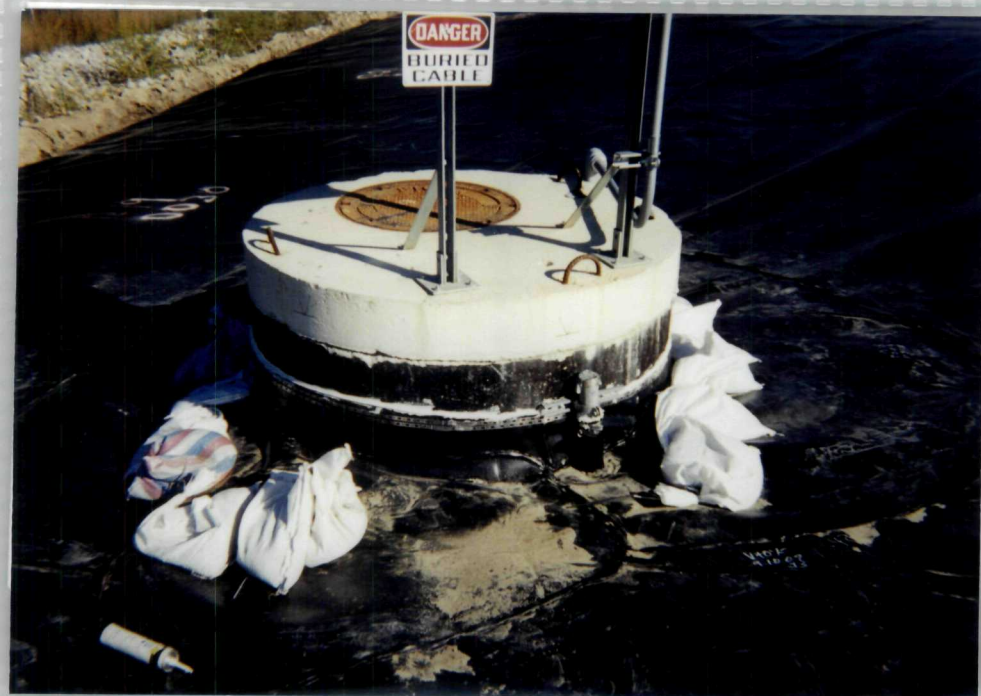
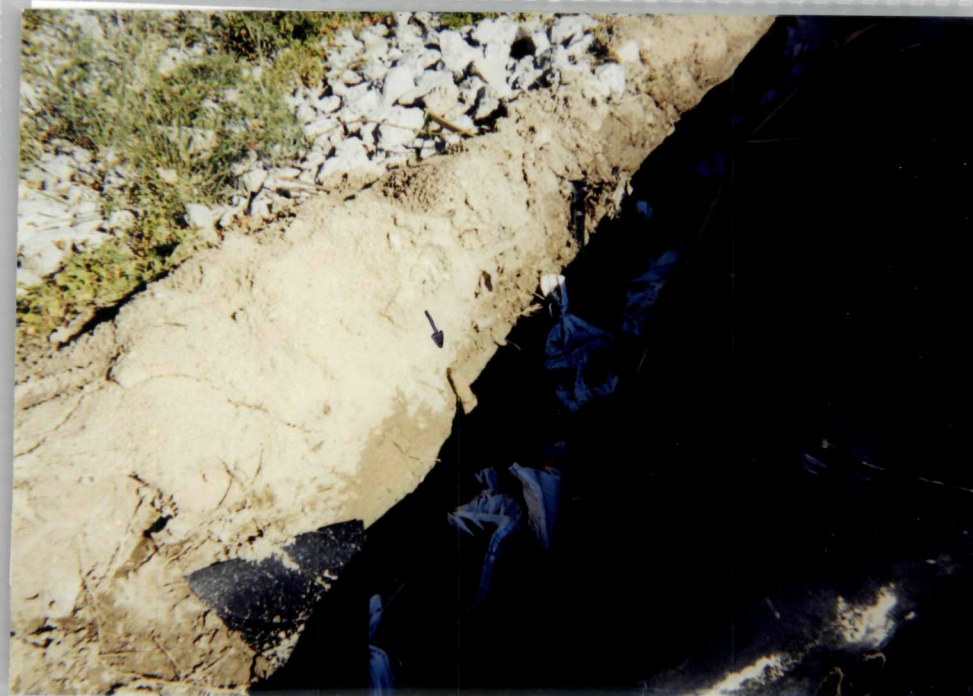
Description: Photo facing northwest showing the FML in the anchor trench on the west side of the OFCA, immediately south of P116. Note auto shock absorber in anchor trench.

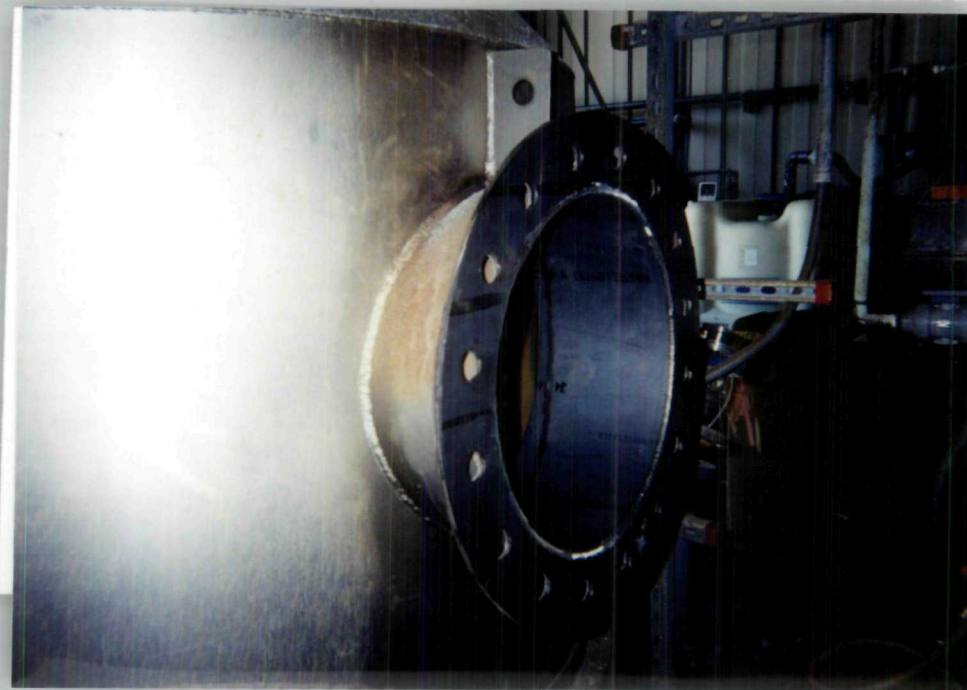
Description: Photo facing northwest showing the Hastelloy sleeve insert welded into the air influent port of the scrubber.

Vidimus welded the repaired duct work connecting the OFCA ISVE system thermal oxidizer and scrubber. MWH installed temporary plastic packing in the scrubber in order to operate the unit. MWH resumed operating the repaired OFCA ISVE system on Wednesday, September 25, 2002. MWH reported that it was drawing vapor from 19 wells. MWH also reported that the dilution air valve in the OFCA blower shed was open at 75% in order to minimize exceeding the temperature limits of the thermal oxidizer and temporary plastic scrubber packing. BVSPC observed that the heat shielding was not replaced on the duct work between the thermal oxidizer and scrubber. BVSPC also observed that MWH did not post signs warning of the elevated temperatures of the duct work. MWH reported that the temperature of the duct after the primary quench bar was approximately 140°F, and was not elevated enough to warrant additional precautions. When asked by BVSPC about the duct work upstream of the primary quench bar that has historically been approximately 600°F, MWH reported that the duct work was out of reach of personnel and did not necessitate any signs.

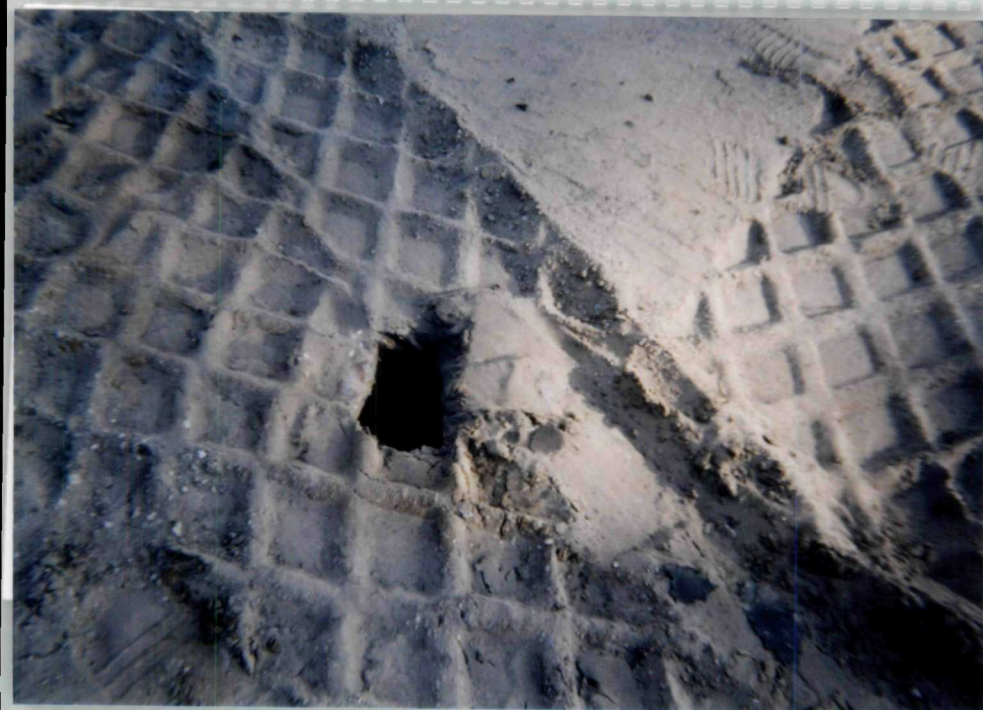
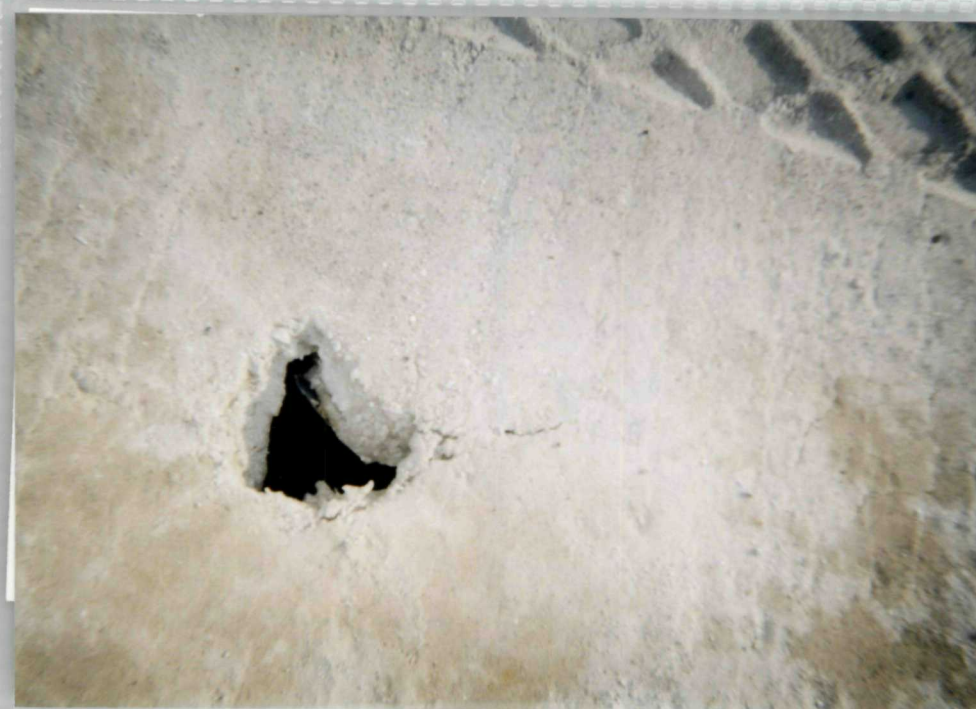
0810 Walked on-site area. HHSI pointed out several voids found in subgrade where former ACS road was. Some debris observed.

Description: Photo facing north at ground of void spaces in the ONCA SBPA subgrade near the ACS employee break room.

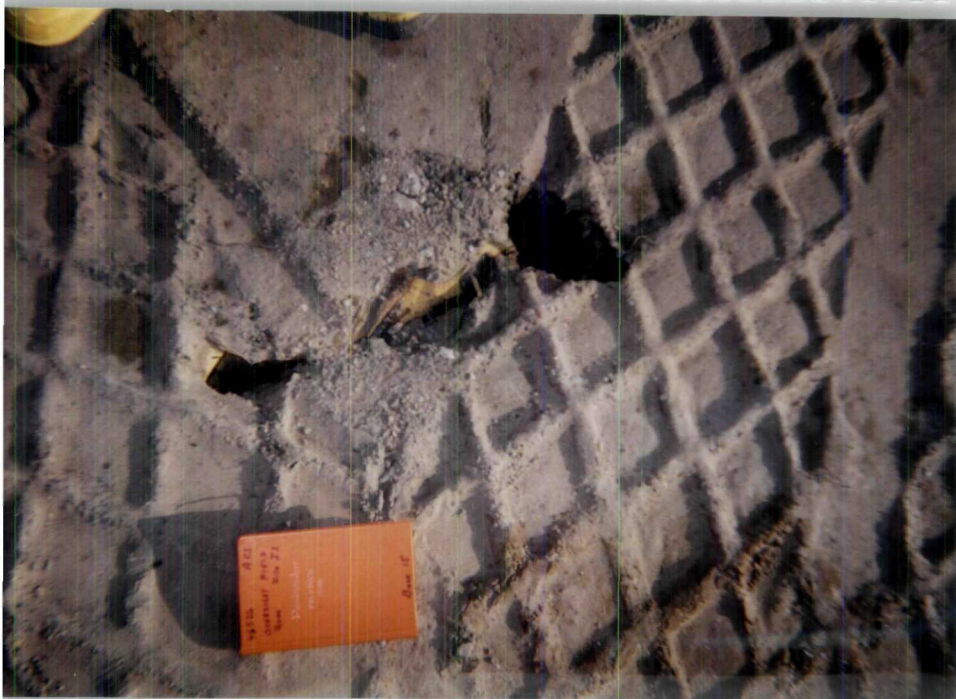
0825 Roll 18 Photos 15 & 16 facing north at ground near ACS employee breakroom at voids. Roll 18 Photo 17 facing north at debris and voids in subbase. PID readings in voids around 10 ppm, but breathing zone PID at 0.1 ppm.

Site: American Chemical Services, Inc.
 Proj. #: 46526
 Roll: 28 Photo #17
 Date: 09-19-02 Time: 08:25
 Photographer: Leigh Peters
 Description: Photo facing north of debris and voids in
 the ONCA SBPA subgrade.
